Manhole Inspection Summary

Manhole # S33QQ_025MH

Insp Date: **4/21/07 9:53 AM**

Location Address: **2506 MARYLAND AVE**

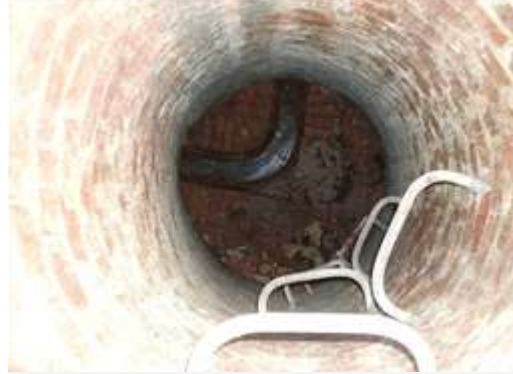
Top View

Bench ☒ Exists Material: **Brick** ☐ Parged ☒ **Debris** (not Condition related)

Channel Material: **Brick** ☐ Parged ☒ **Debris** (not Condition related)

Surcharge ☒ **Evidence Of Surcharge** Depth: **1** (ft.) ☐ Active Surcharge Present

Evidence of surcharge - Bench debris.
Channel debris.

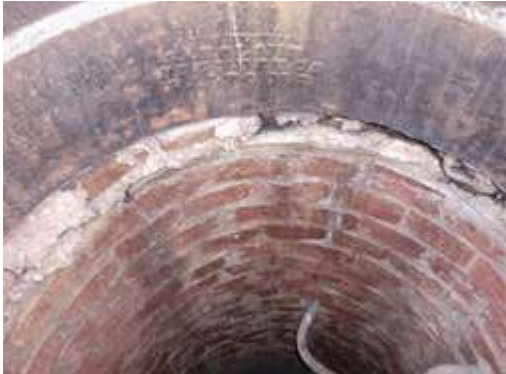
Defect

Condition: ☐ Sound ☐ Cracked ☐ Root Intrusion ☐ Loose Brick ☒ **Deteriorated**

Infiltration: ☐ None ☒ **Joint** ☐ Cracks ☐ Mortar ☐ Roots ☐ Wall

Infiltration: ☐ None ☐ Joint ☐ Cracks ☐ Mortar ☐ Roots ☒ **Wall**

Adjustment deterioration and infiltration.
Barrel infiltration - other side.

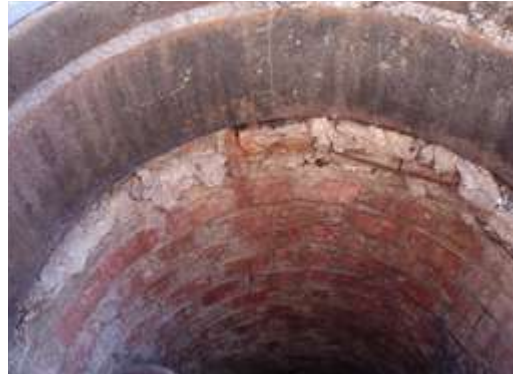
Defect

Adjustment deterioration and infiltration.
Barrel infiltration.

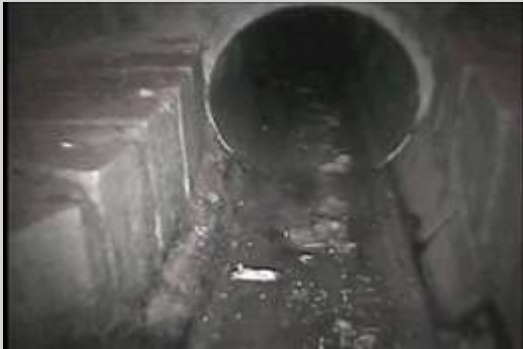
8 in. Circular Gravity Sewer Pipe Out @ 12 O'Clock

Deposits: ☐ None ☒ **Mud** ☐ Sludge ☒ **Debris** ☐ Grease

Silt Depth: **0** (in.) Deposits Extent: **Light**

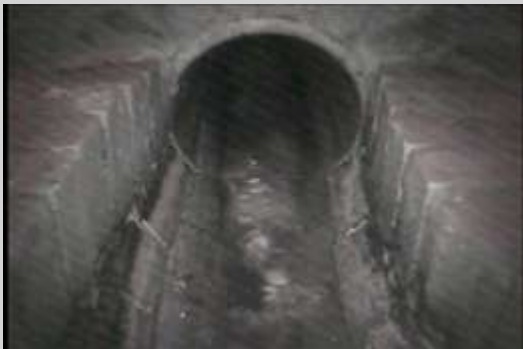
8 in. Circular Gravity Sewer Pipe In @ 3 O'Clock

Deposits: ☐ None ☒ **Mud** ☐ Sludge ☒ **Debris** ☒ **Grease**

Silt Depth: **0** (in.) Deposits Extent: **Light**
